**2003 FIELD SURVEY FOR WILLOW ESTABLISHMENT
POTENTIAL ON THE CURLEW NATIONAL
GRASSLAND, ONEIDA COUNTY, IDAHO**

Jenae Dixon

2004

Idaho Conservation
Data Center
Idaho Department of
Fish and Game
PO Box 25
Boise, Idaho
83707

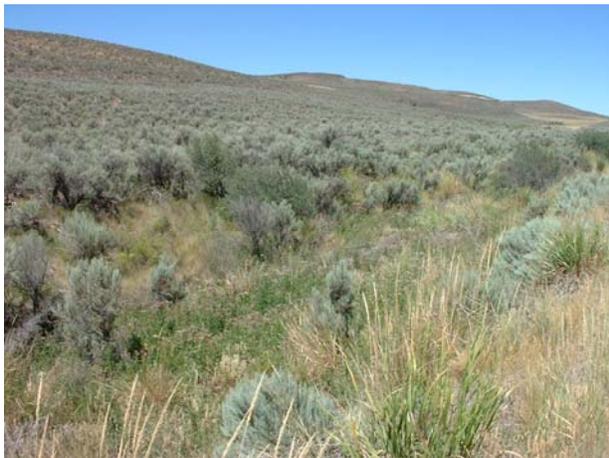
Figure 1. Upland and invasive species overtaking the dry portion of Rock Creek north of Twin Springs. Facing nw.

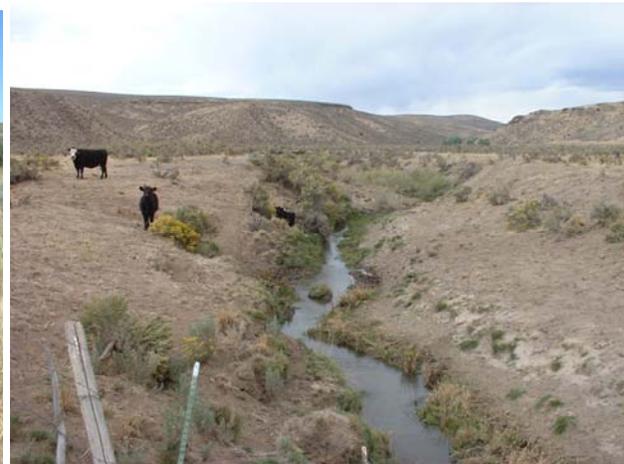
Figure 2. Rock Creek at its confluence with Meadow Brook Creek. Downcutting is less severe here than just upstream. Facing n.

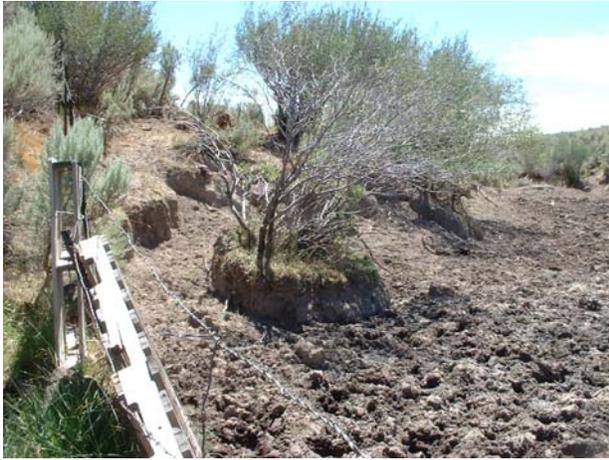
Figure 3. Rock Creek. Just s of fence at s border of Lonigan Springs. Facing se.

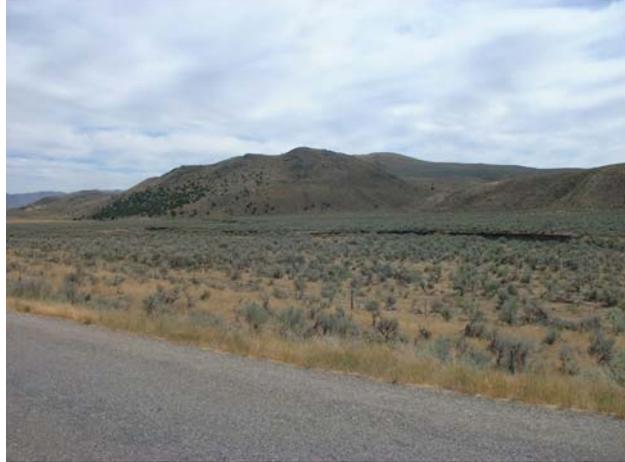
Figure 4. Rock Creek downcutting north of Meadow Brook Creek (confluence at base of tallest peak). Bank erosion continues to base of hill, center photo. Facing sw, from Highway 37.

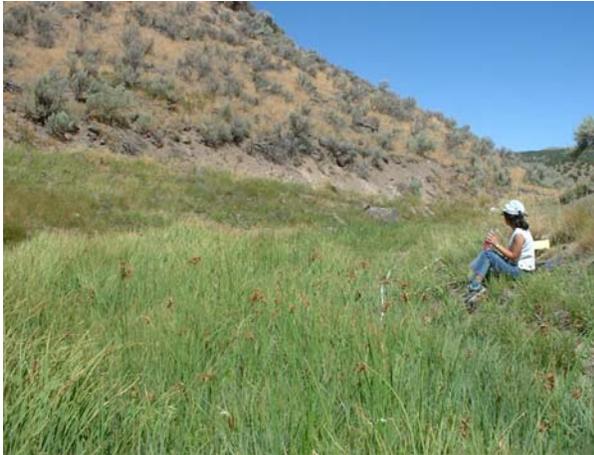
Plot 03JD03 was sampled along the channel (Figures 5 and 6; Appendix C). Plant community information is summarized in Table 3. Native graminoids such as hardstem bulrush, Nebraska sedge, and common spikerush dominate the vegetation.

Figure 5. Meadow Brook Creek transect site, before grazing (August 8). Facing e.

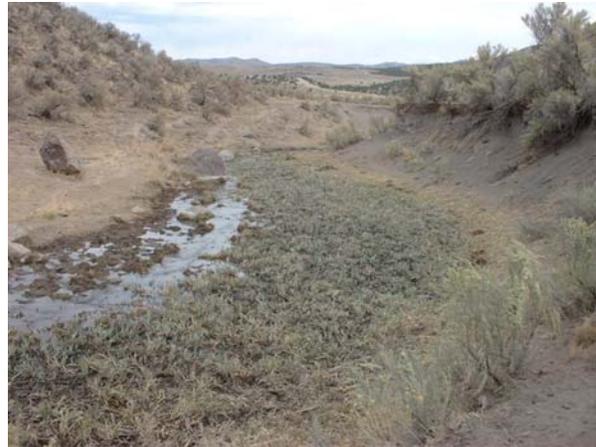
Figure 6. Meadow Brook Creek transect site, after grazing (October 1). Facing e.

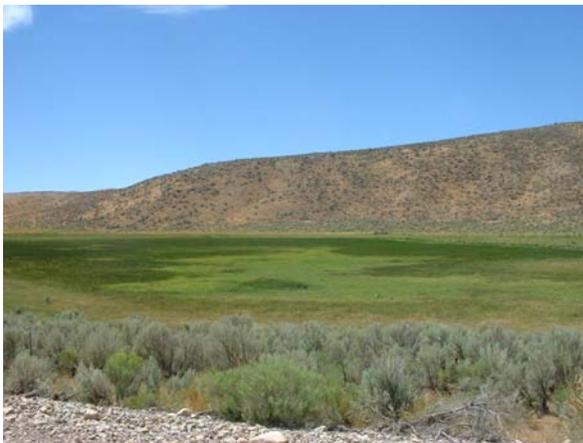
Three mesic meadows along Meadow Brook Creek (Figure 7) occupy approximately 50% of Meadow Brook Creek's length on the CNG. Native riparian species such as Nebraska sedge, hardstem bulrush (*Scirpus acutus*) and common spikerush (*Eleocharis palustris*) dominate. These meadows experienced heavy cattle grazing impacts in 2003 (Figure 8). The two upper meadows are threatened by headcutting; the lower is threatened by downcutting.

Figure 7. Meadow Brook Creek, before grazing (August 8). Facing n.

The three meadows are poised to be eliminated by the head- and downcuts at their downstream borders. The upper headcut has been reinforced with riprap, but the other two are apparently untreated. I recommend bank and headcut stabilization with native woody and graminoid species. In addition, I recommend the two headcuts furthest downstream be structurally reinforced.

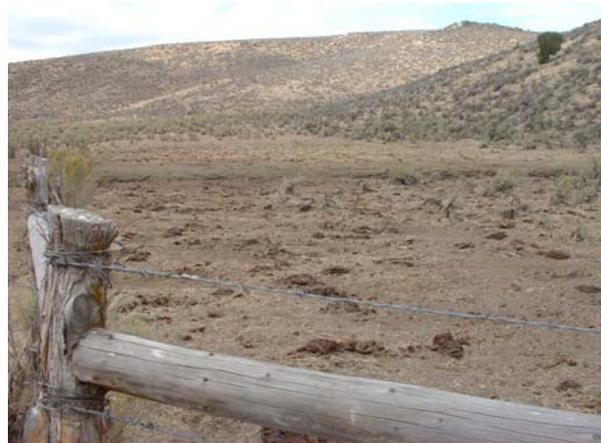
Figure 8. Meadow Brook Creek, after grazing (October 1). Facing n. Near, but not the same site as Figure 7. Channel runs horizontally in photo, 2/3 from bottom of photo.
